**O & M INSPECTION REPORT
FOR NAVIGATION AND SHORE PROTECTION PROJECTS**

1. Project Name: Honokahau SBH
2. Date of Inspection: 8 May 2002
3. Inspection Personnel:

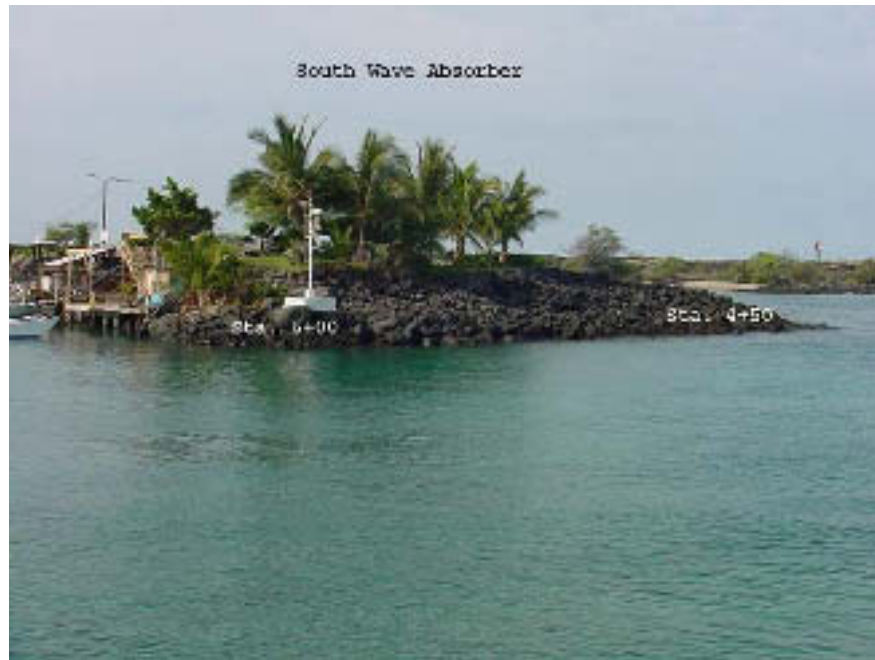
a. South Wave Absorber, Overview

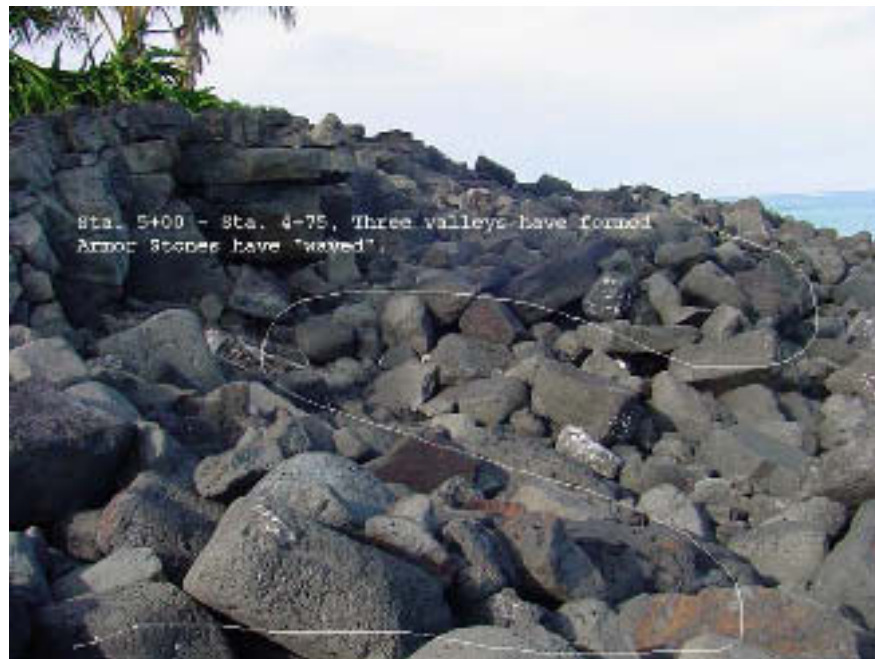
b. Sta. 5+75; Sta. 5+20 and Sta. 4+90, armor stones have been pushed up by wave action, this causes a 2' mound and associated 2' depression in the sideslope.

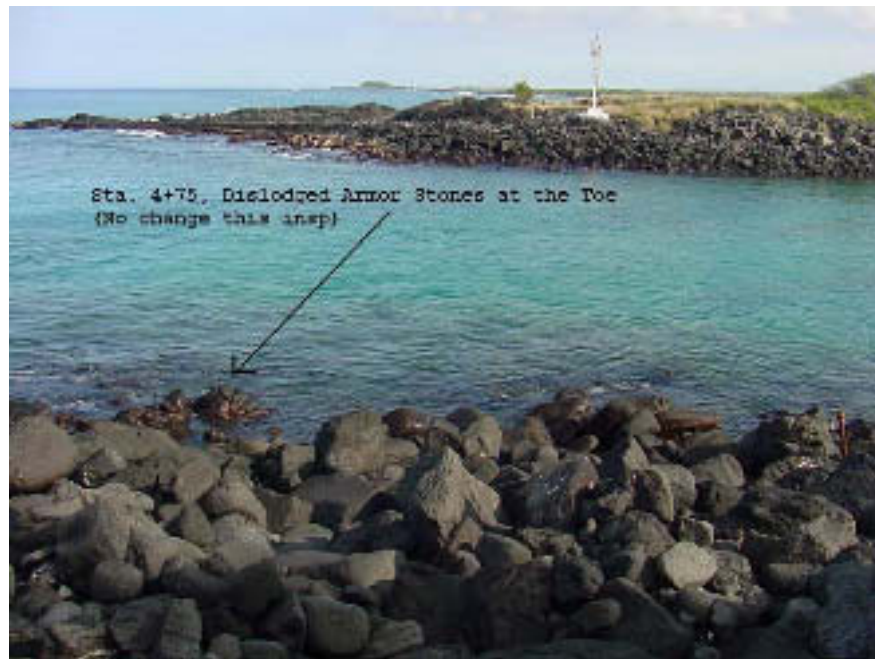
c. Sta. 4+75, armor stones are dislodged at the toe and have caused a void at the waterline.

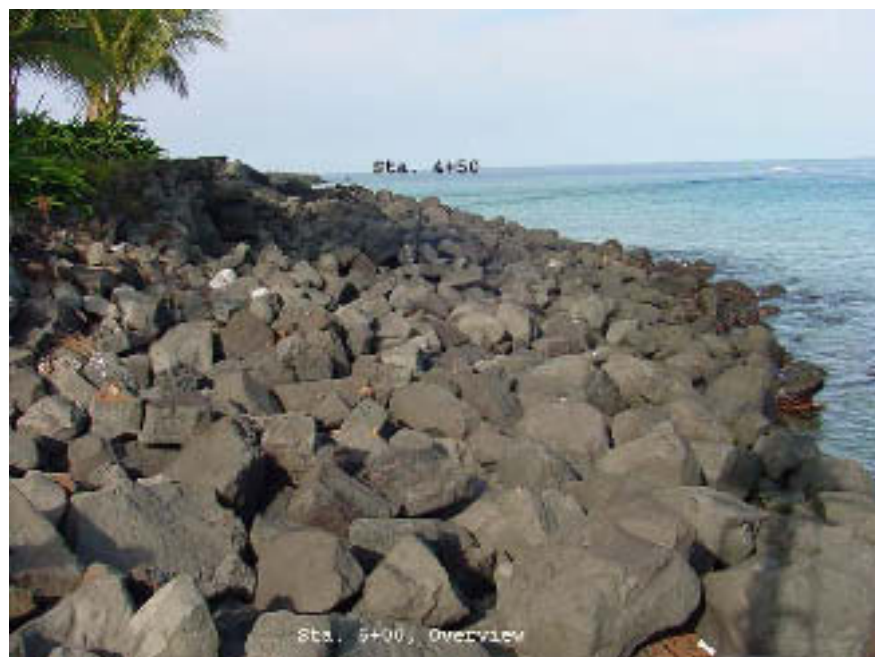
d. South Wave Absorber reference photo.

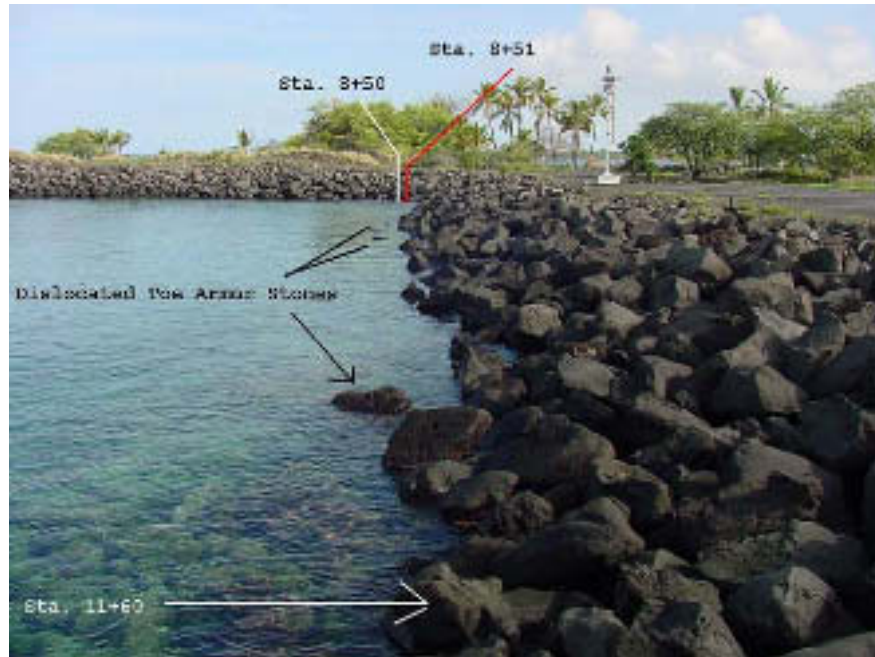
a. Sta. 11+60 thru Sta. 8+51, numerous toe armor stones are displaced at the waterline.

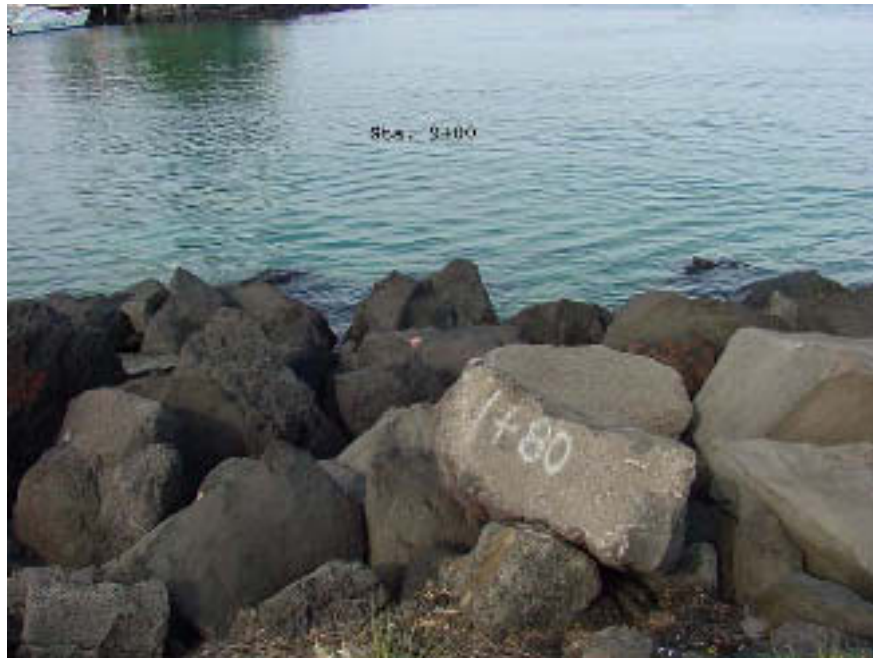
b. Sta. 9+00, dislodged armor stone at the toe. (verify station next insp).

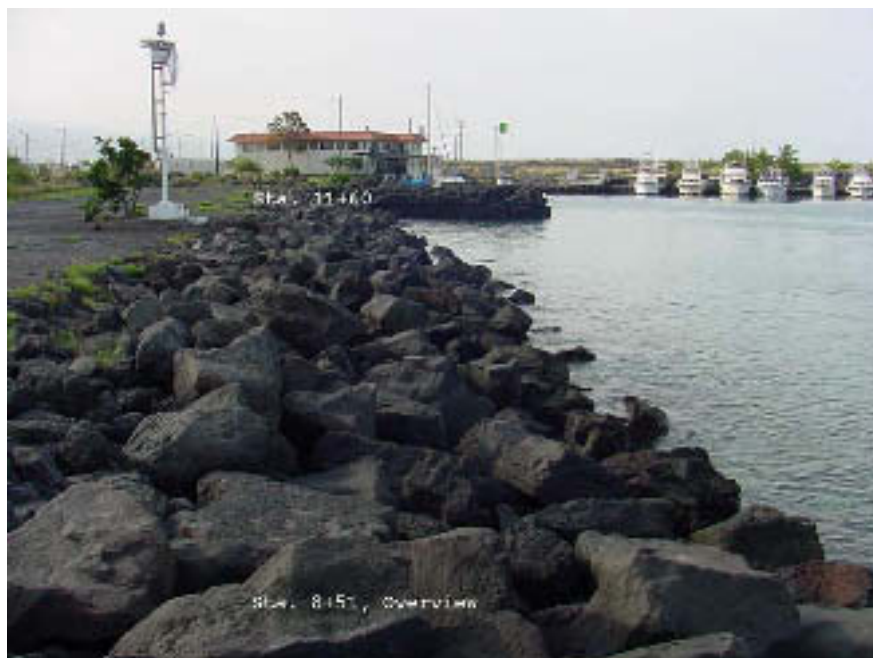
c. Sta. 8+51, Overview (east-side).

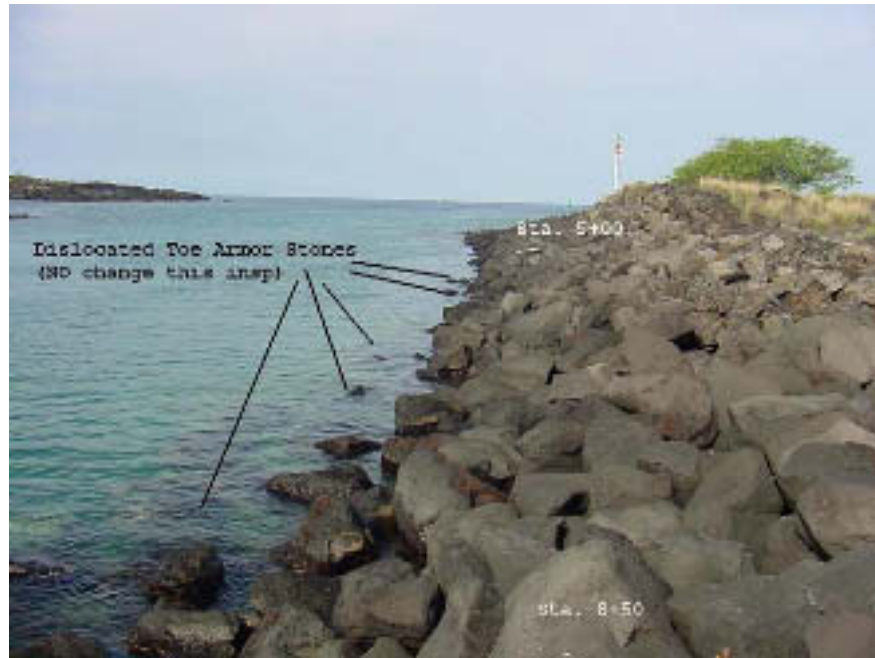
d. Sta. 8+50 - Sta. 5+00, (north-side), dislocated toe armor stones.

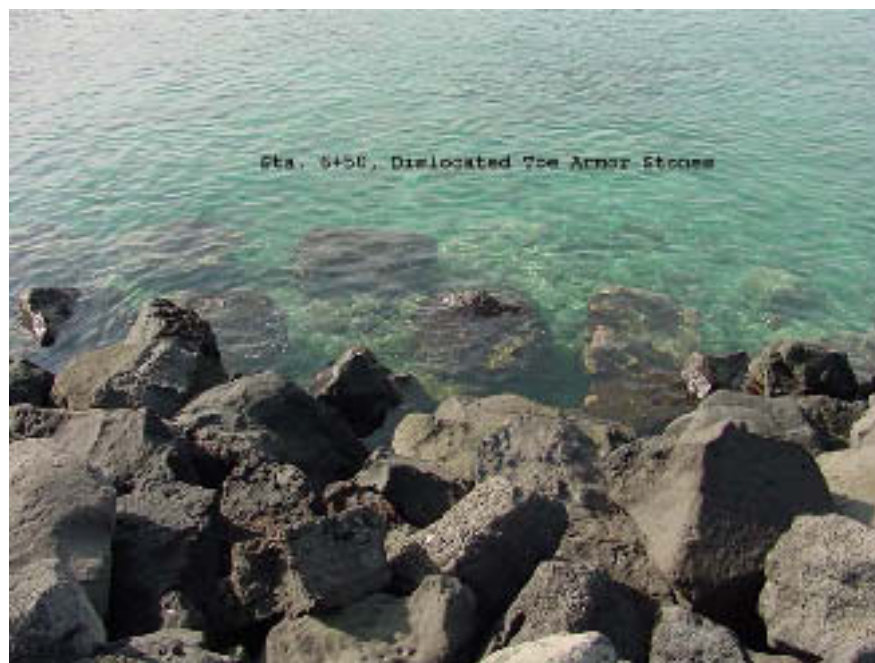
e. Sta. 6+50, displaced armor stone resting adjacent toe.

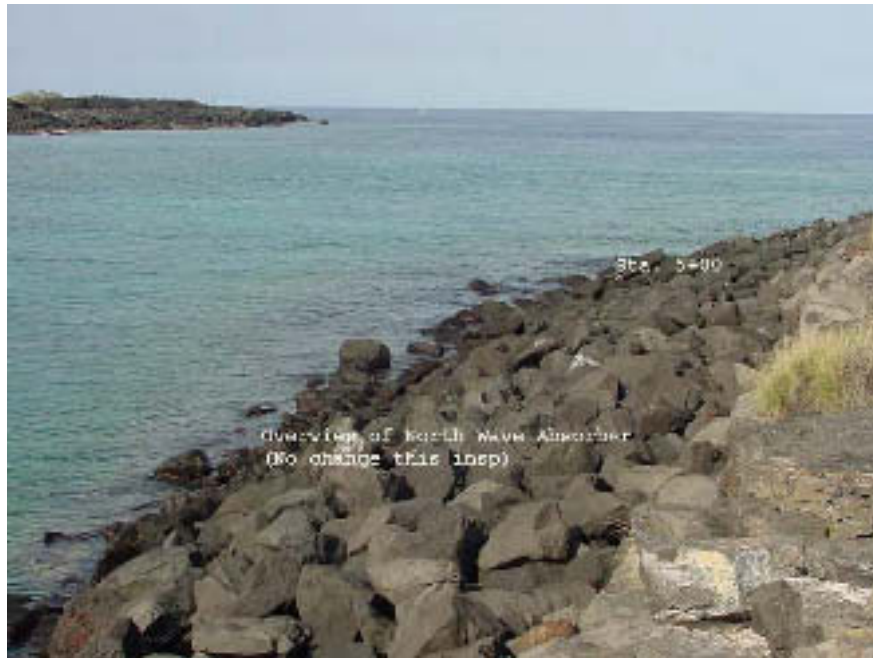
f. Sta. 5+00, Overview reference photo.
